Report To: COW - Operations, Planning and Building Services
Meeting Date: March 18, 2025
Report Number: OPS.25.017
Title: Happy Valley Reservoir Budget Increase
Prepared by: Allison Kershaw, Manager of Water & Wastewater Services

**Happy Valley Reservoir (North and South)
Remotely Operated Vehicle Inspection and Report
July 31, 2019**

Remotely Operated Vehicle Inspection & Report (ROV) – Happy Valley Reservoirs (North and South)

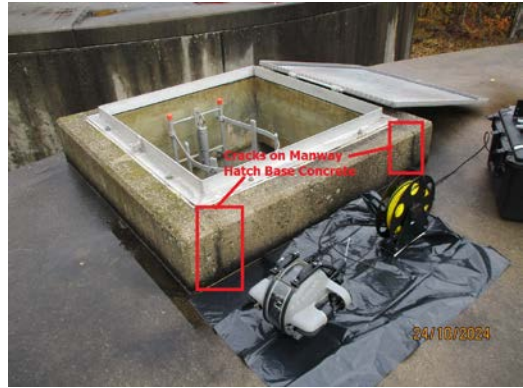
Concrete base for roof manway; two cracks marked

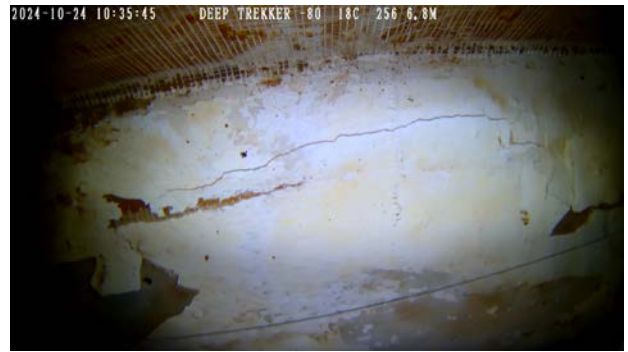
Cleared sediment away; cracked parging underneath

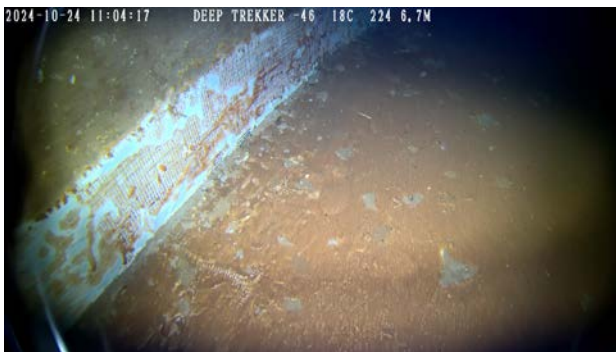
Wall to floor joint

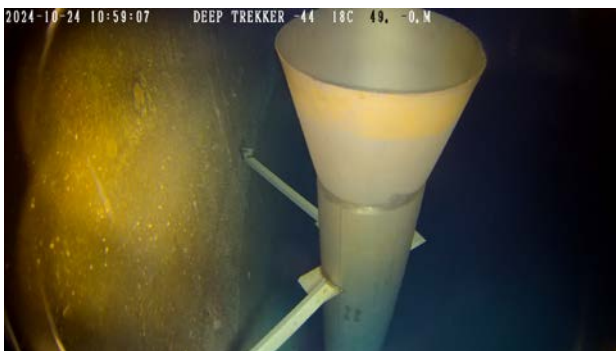
Stainless steel funnel and vertical pipe

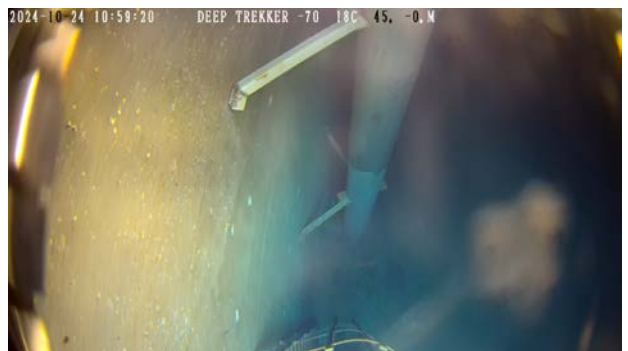
View stainless steel pipe and brackets

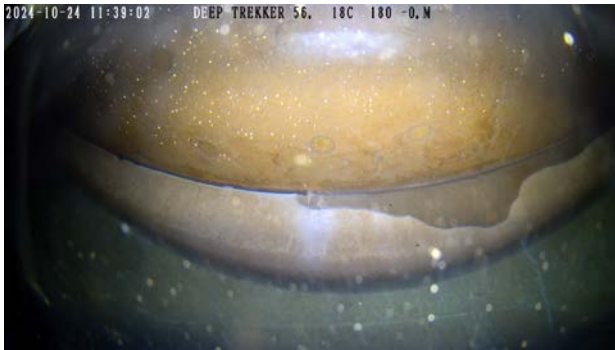
Roof to wall joint; some staining seen

- 4.4 If and when the reservoir cells are entered for cleaning, maintenance or repairs, take the opportunity to test the integrity of the upper roof to wall joint seals, method to be discussed.

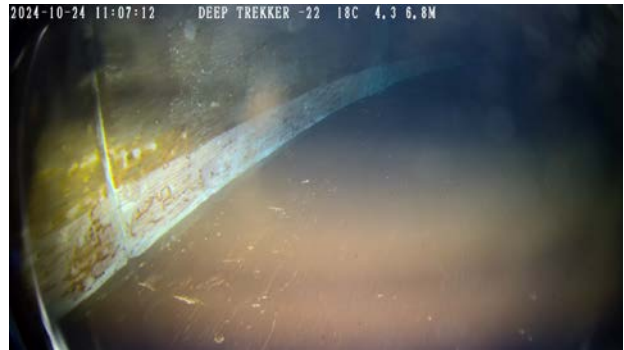
Wide view of wall to floor joint

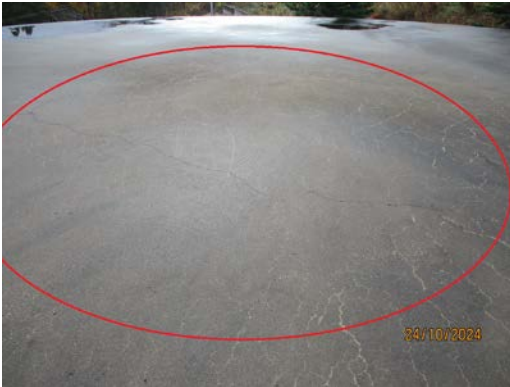
Roof top cracks around centre support area

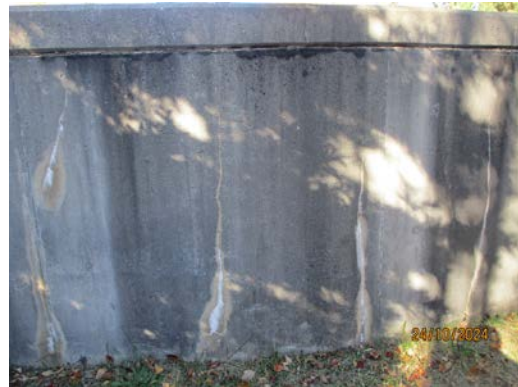
Example of multiple cracks with white deposits

- 4.5 Remove external calcium and other deposits seen at random areas of the reservoir and at joints and monitor periodically to see if these areas have active leakage or increasing size.

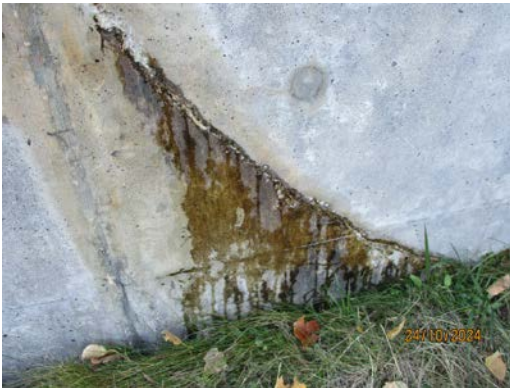
View of wet deposits from concrete layer

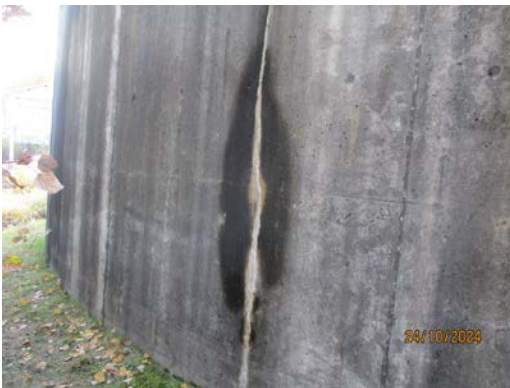
Example of crack indication with white deposits

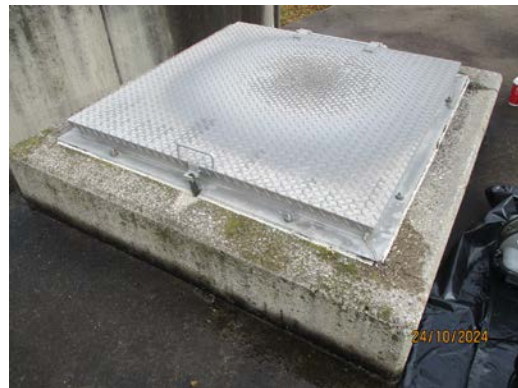
Roof hatch secured and locked after inspection

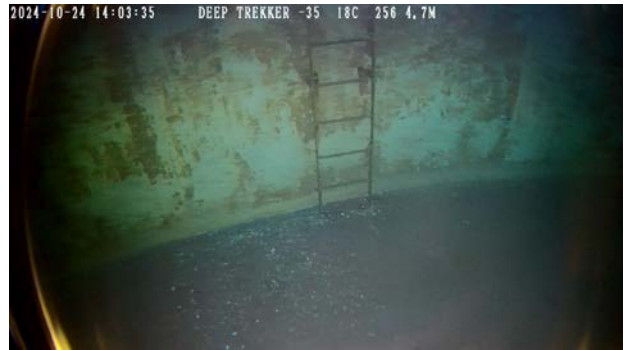
Ladder bottom, bits of scale laying loose on floor

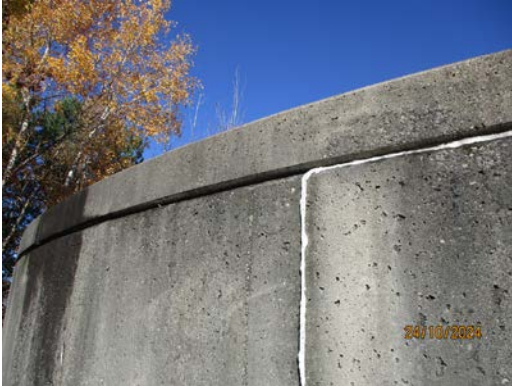
Grouting missing - external roof-wall joint

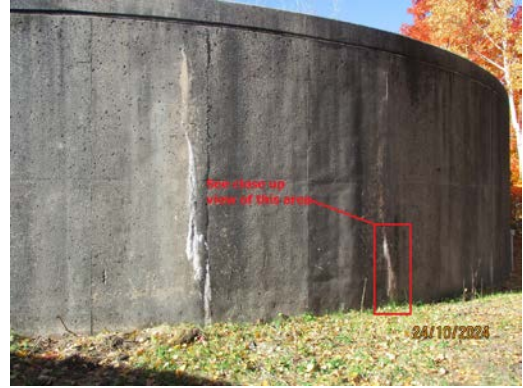
* Typical cracking with white deposits

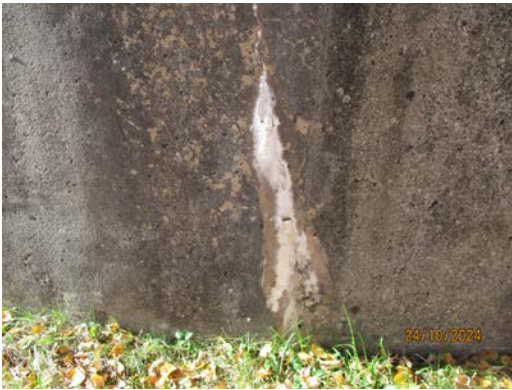
*Close up view: Typical cracking

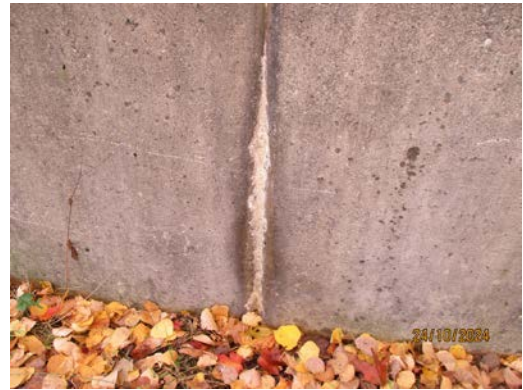
Typical area of white deposits at joint
