Visual Inspection of the Accessible Internal & External Areas of the Happy Valley Potable Water Reservoirs

Project : 2024-17-Q-OPS, Inspection of the Two (2) Happy Valley Reservoirs

AIS Job No. : 20241009-TBM-01

ROV INSPECTION REPORT

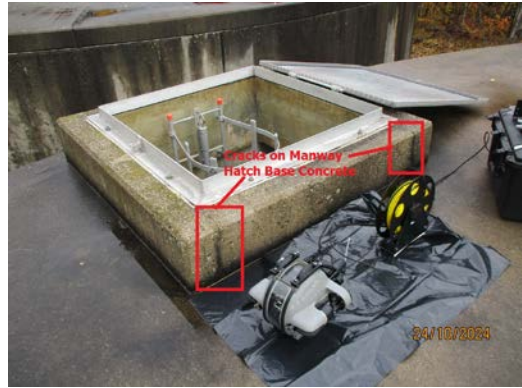
Concrete base for roof manway; two cracks marked

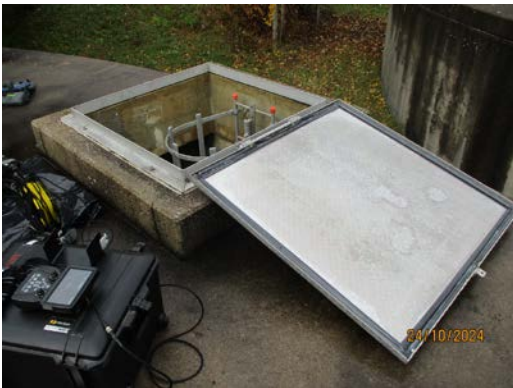
Manway cover; rubber seal in good condition

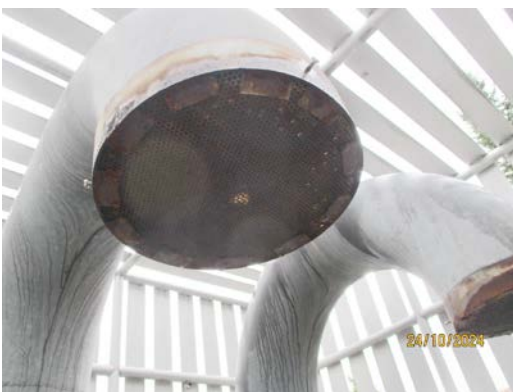
Underside of 1st gooseneck vent screen – ok

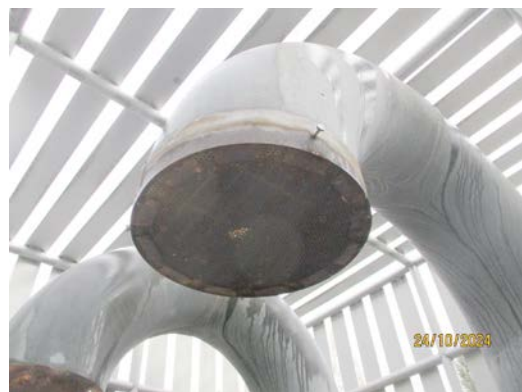
Underside of 2nd gooseneck vent screen – ok

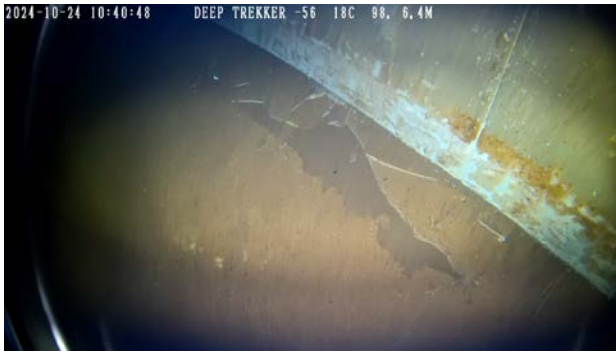
Outer floor, parging layer flaked off

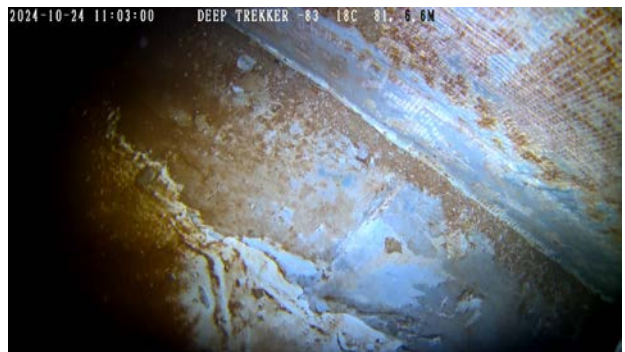
Floor to wall area; sediment cleared away by ROV

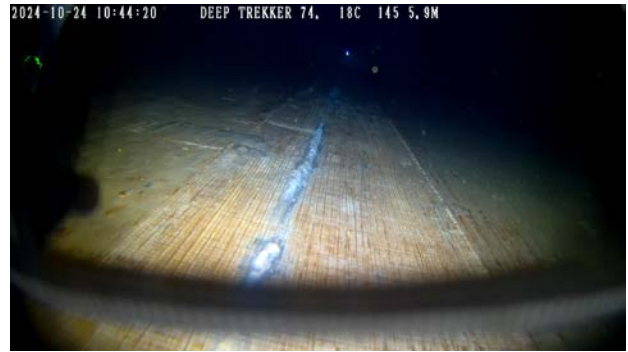
View up wall joint; white deposits coming through

- 4.5 Remove external calcium and other deposits seen at random areas of the reservoir and at joints and monitor periodically to see if these areas have active leakage or increasing size.

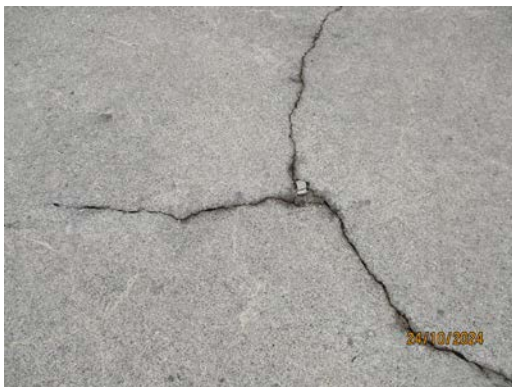
Roof top “spider crack”

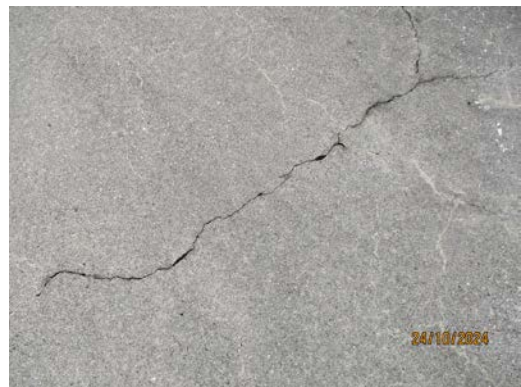
Typical roof topside crack

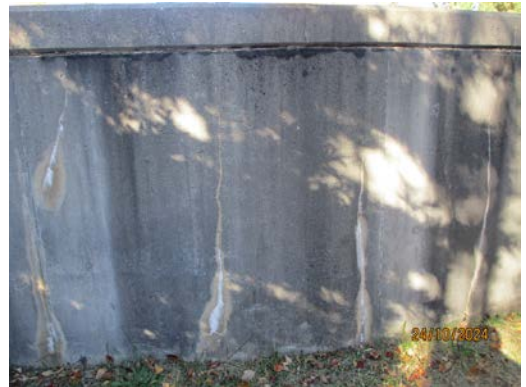
Example of multiple cracks with white deposits

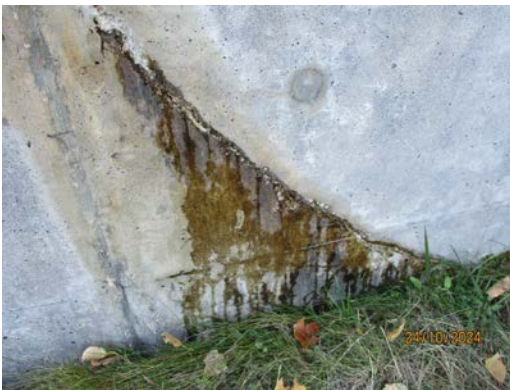
View of wet deposits from concrete layer

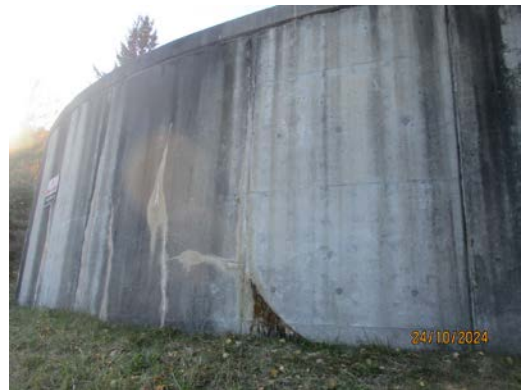
Wide view of area where wet deposits are seen

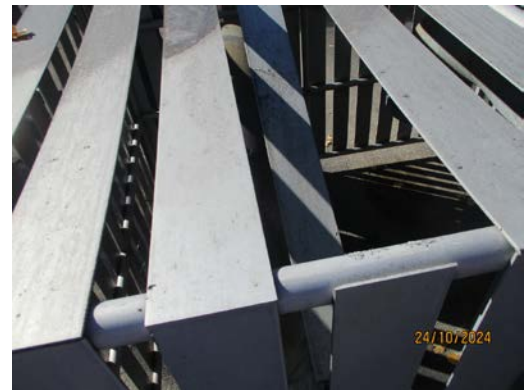
One strap on top of protective cage is bent inward

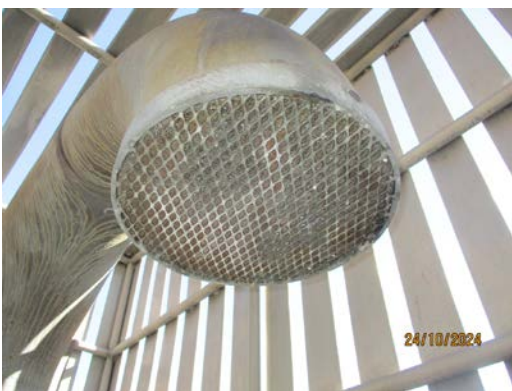
Vent one of two, screening is ok

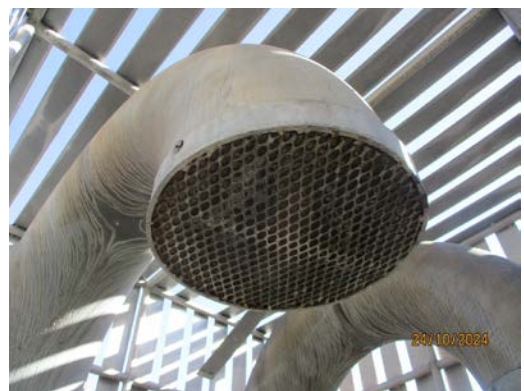
Vent two of two, screening is ok

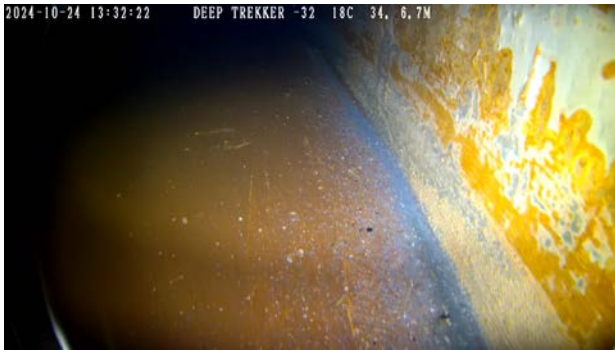
Wall to floor area, blue bits of grainy debris

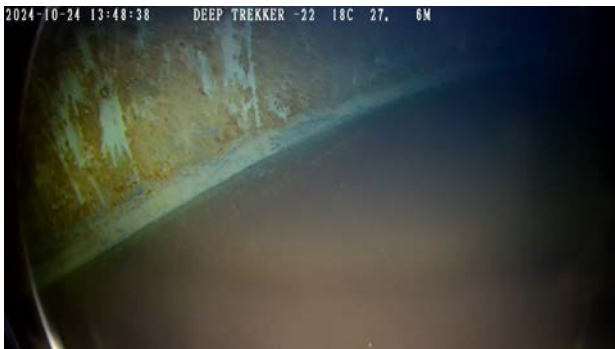
Typical thin layer of sediment across the floor

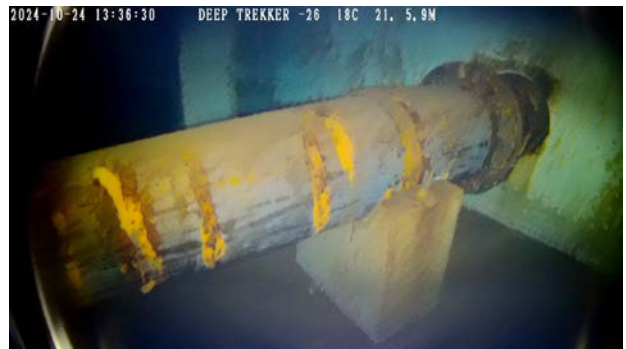
Fill pipe to wall interface, scale deposits on pipe

- 4.2 Plan to dewater and enter each of the two reservoirs and perform cleaning as well as more detailed inspections of the metal parts, thickness of piping, bolting corrosion including removal of scale and failed coating to better assess condition of these metal components.

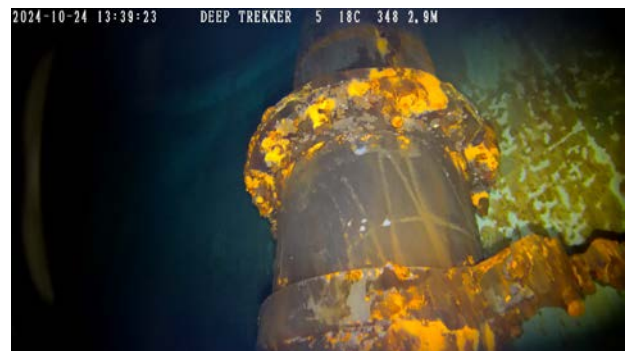
Scale and deposits on overflow piping & bracket

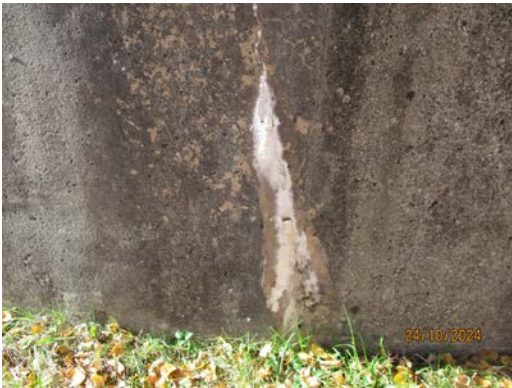
*Close up view: Typical cracking

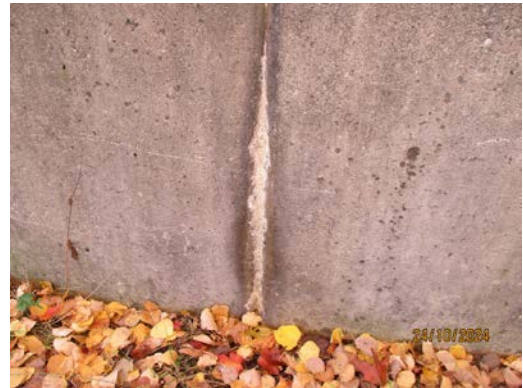
Typical area of white deposits at joint
