Intersection Signage at Gibraltar - Engineering Opinion Letter

As requested, please see the following traffic engineering opinion letter for the intersection of 4th Line and Side Road 6, Gibraltar, within the Town of Blue Mountains.

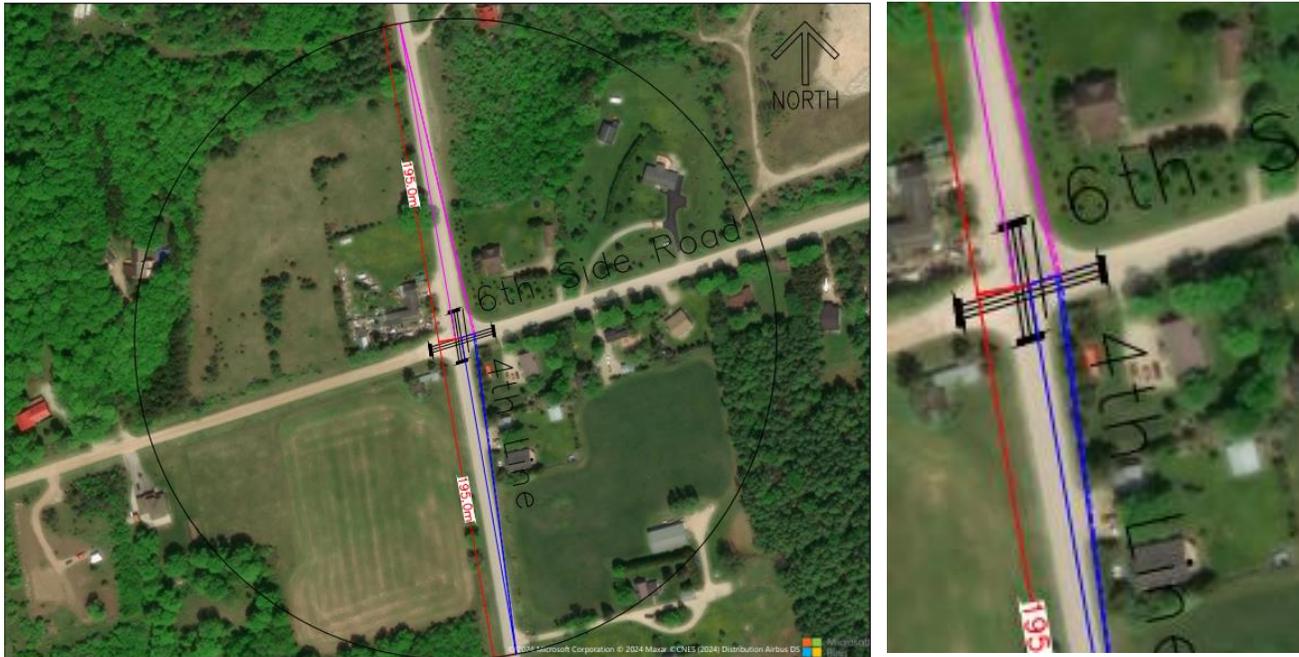
Figure 1: 4th Line and Side Road 6 Departure Sight Triangle

Visibility is key at intersections and industry standards¹, provides guidance of providing stopping sight distance at intersections. If visibility is obstructed due to environmental constraints, and all other options are not practical, then an all-way stop controlled intersection will need to be considered. As per TAC Manual Chapter 9, the specified areas along the intersection approach legs and the corners should be free of obstructions that can potentially block the drivers view of conflicting vehicles. The geometry between both points at the minor and major road approaches create a sight triangle as shown in Figure 1. As indicated in Figure 1, trees and bushes are in the southeast corner which obstructs sight lines. As mentioned in the town's mitigation measures, bushes have been removed to avoid interference with sight lines, however the bushes and trees closer to the intersection fall under private property and the Town will need to further review bylaws etc. to see if they can be removed.

Also, 4th Line experiences a rolling profile either side of the intersection, particularly for those heading north to the intersection. Therefore, it can be determined from a visibility perspective that all-way stop control is currently warranted at this intersection.

At the intersection, the Town has installed additional stop ahead signs and oversized stop signs raising them to upper range in height (bottom of the sign is 2.0m). Due to the layout of the intersection, the stop sign along the east side of Side Road 6 is shifted to around 18 m from the intersection, assumed to accommodate the turning movements of larger vehicles, and this could be investigated to be closer as it's beyond the recommended range of 15 m as per OTM Book 5. However, no issues have been observed with the signage used. From available imagery (dated Aug 2023) there are no pavement markings on 4th Line or at the intersection (i.e. stop bars).

It is recommended the Town consider implementing pavement markings (the stop bars on each arm at a minimum) and re-evaluate the location of the eastern arm stop sign. Further, the Town could consider the use of video monitoring at the intersection, to validate the concerns and/or the effectiveness of the pavement marking, if implemented. The argument to OPP not observing any non-compliance, is that drivers will alter their behaviour at the sight of the OPP. Video monitoring could therefore provide further validation through a record of uninfluenced driver behaviour at the intersection.
