## Thornbury West Reconstruction Project

## Arborist Report

Town of the Blue Mountains  
February 12, 2021  
ETi File ET120013-1

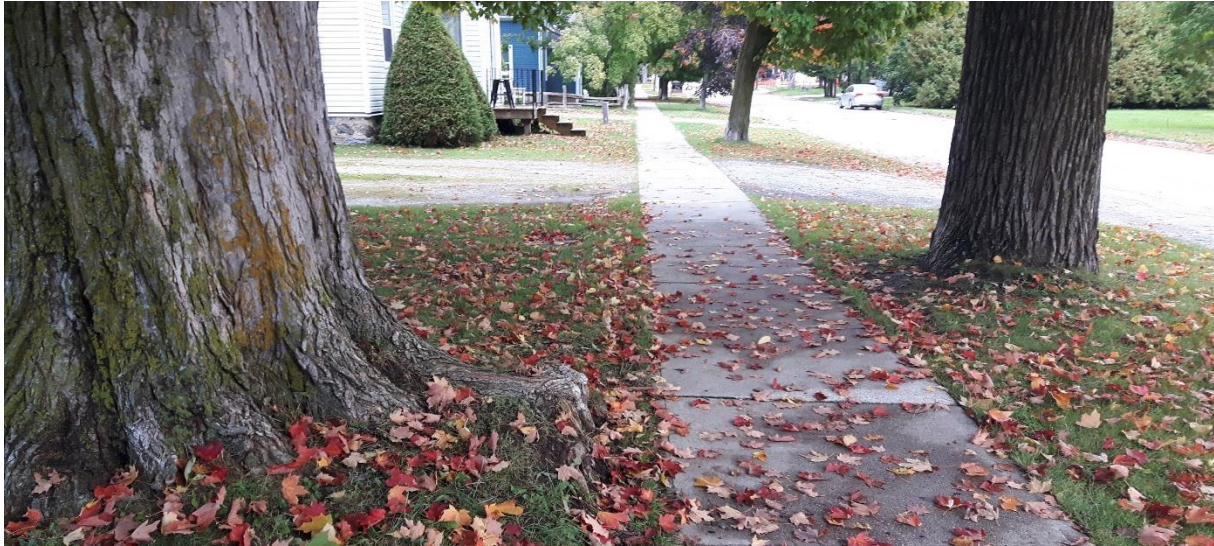
Several sections of the streetscape were dominated by mature and over-mature trees, many of which were located immediately adjacent to sidewalks (**Figure 2**). Several of the inventoried trees had poor structure, decay, and other defects characteristic of poor maintenance (**Figure 3**).

**Figure 2.** Mature trees near sidewalks

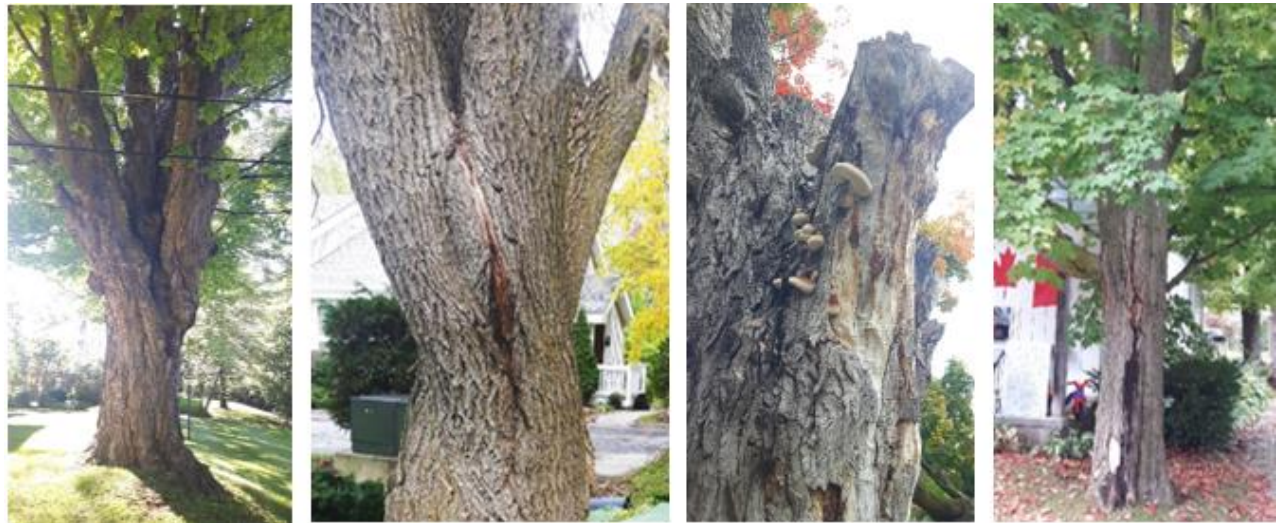
**Figure 3.** Mature trees with poor structure and decay

Many of the declining deciduous trees have been poorly maintained. We recommend that the Town consider allocating funds to public tree maintenance to improve the longevity of trees.
