Staff Report

Report To: COW - Operations, Planning and Building Services
Meeting Date: March 18, 2025
Report Number: OPS.25.013
Title: Gibraltar Stop Signs
Prepared by: Jim McCannell, Manager of Roads & Drainage

Intersection Signage at Gibraltar - Engineering Opinion Letter

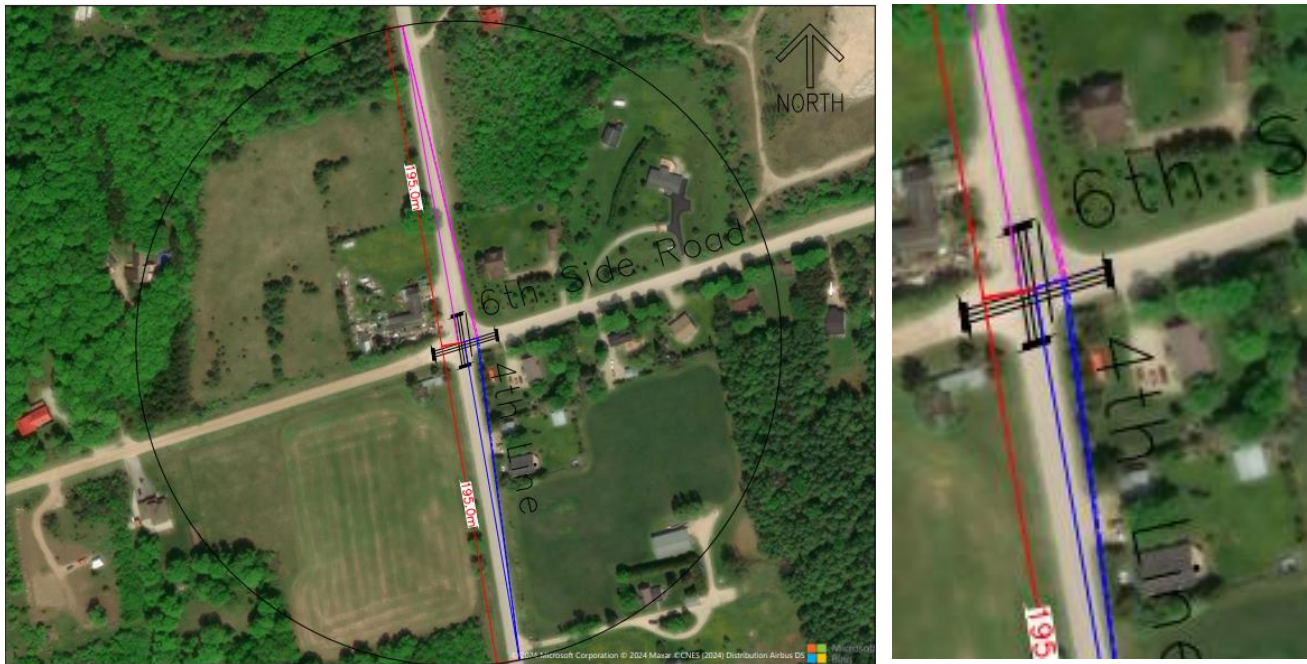
Figure 1: 4th Line and Side Road 6 Departure Sight Triangle

At the intersection, the Town has installed additional stop ahead signs and oversized stop signs raising them to upper range in height (bottom of the sign is 2.0m). Due to the layout of the intersection, the stop sign along the east side of Side Road 6 is shifted to around 18 m from the intersection, assumed to accommodate the turning movements of larger vehicles, and this could be investigated to be closer as it's beyond the recommended range of 15 m as per OTM Book 5. However, no issues have been observed with the signage used. From available imagery (dated Aug 2023) there are no pavement markings on 4th Line or at the intersection (i.e. stop bars).

OPP have attended the area for enforcement and according to their reports from their onsite activity had mentioned no vehicles running the intersection, however, have observed rolling stops from the residents at the intersection. In addition, the Town of Blue Mountains have reached out to the First Student Inc. regarding sight lines to which they reported no concerns with the visibility of the stop signs or issues with the signs themselves.

It is recommended the Town consider implementing pavement markings (the stop bars on each arm at a minimum) and re-evaluate the location of the eastern arm stop sign. Further, the Town could consider the use of video monitoring at the intersection, to validate the concerns and/or the effectiveness of the pavement marking, if implemented. The argument to OPP not observing any non-compliance, is that drivers will alter their behaviour at the sight of the OPP. Video monitoring could therefore provide further validation through a record of uninfluenced driver behaviour at the intersection.
