Staff Report

Report To: Committee of the Whole
Meeting Date: November 17, 2020
Report Number: CSOPS.20.066
Subject: Thornbury WWTP Headworks Update
Prepared by: Allison Kershaw, Manager of Water and Wastewater Services &
Brent Rolufs, Senior Infrastructure Capital Project Coordinator

Headworks - Photo Log

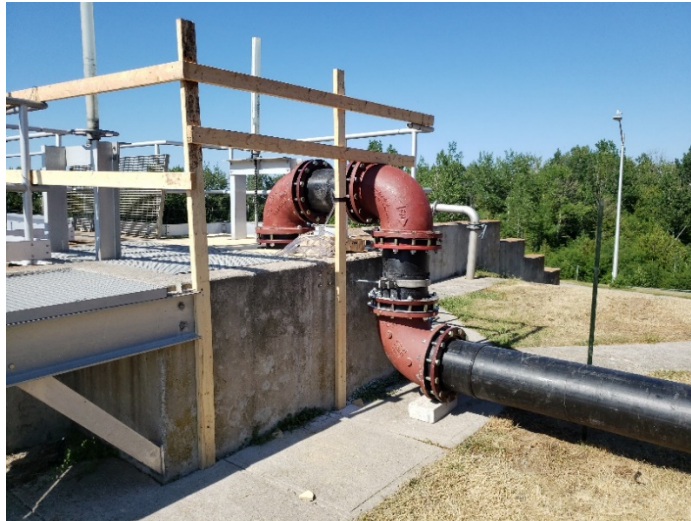
Photo No. 1

- Temporary Bypass piping around headworks building,
- Temporary Bypass piping allows full time access for the contractor to complete headworks expansion.

The Town's contractor, H2Ontario, mobilized to the site during the last week of May 2020. The temporary by-pass to redirect the influent flow directly to the aeration basins was installed and operational by mid-June. This temporary line required the installation of flow monitoring equipment and an automatic sampler to ensure compliance with the Town's Environmental Compliance Approval issued by the Ministry of the Environment, Conservation & Parks (Photo No. 1 in the attachment).

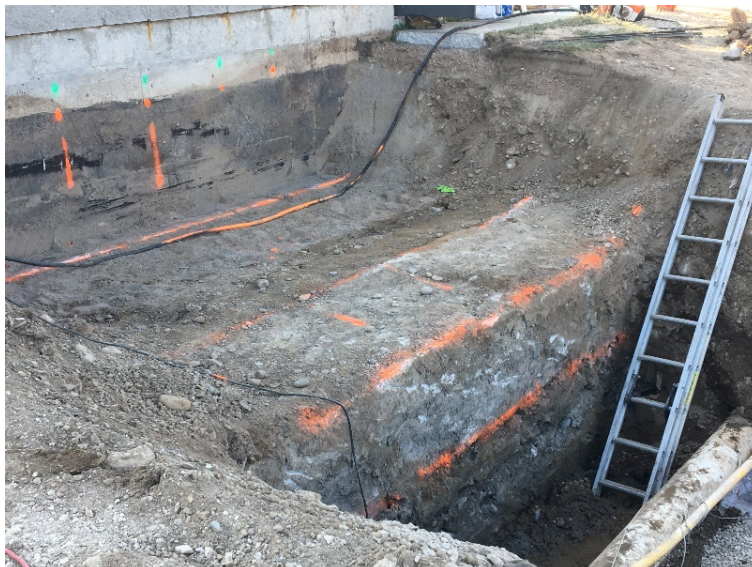
Photo No. 2

- Electrical Duct bank that was installed during the original construction.
- Duct bank is not in the location of the Engineering Record Drawings resulting in re-engineering and additional construction activities to install the piping into the Headworks Building.

During the installation of the temporary bypass lines it was determined that the historical record drawings were incorrect in identifying the location and size of the existing buried electrical concrete conduit. The result of these buried utilities not being correctly identified on the record drawings impacted the installation of all five influent lines that enter into the west side of the Headworks Building. The Town's consultant, JL Richards, was notified of the design conflict and a change in execution was required to resolve the buried piping alignment. Collaboration between JL Richards, H2Ontario and the Town resulted in an economical design modification. All five of the influent lines required realignment which in turn required additional piping quantities and time for both JL Richards and H2Ontario to complete the installation. The additional work was executed on a time and material basis to resolve the piping alignment conflict. The total anticipated cost of this Contract Change Order is \$24,427 and the staff project manager was on site full time to ensure the extra charges were correct. This Contract Change Order has not been approved. See Photos No. 2, 3 and 4 in the attachment.

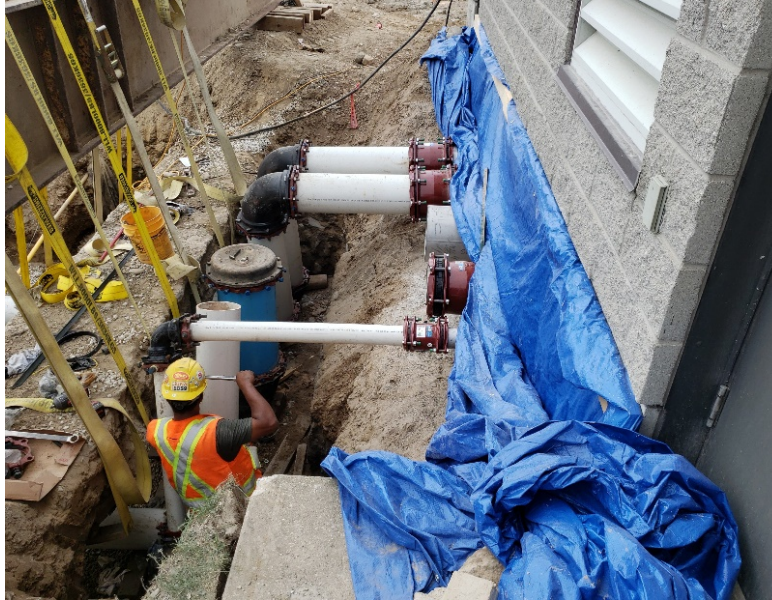
Photo No. 3

- Electrical Duct bank being supported to allow for excavation under the electrical duct bank for installation of the piping.

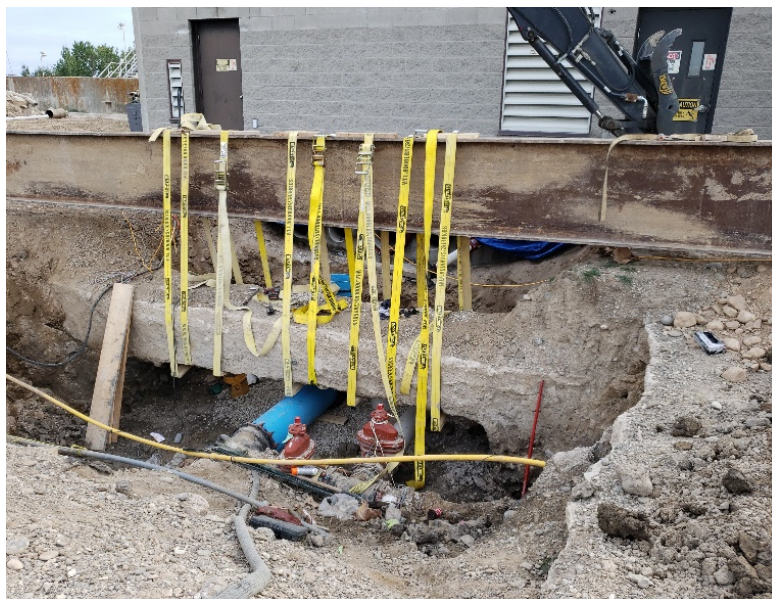
Photo No. 4

- Electrical Duct bank being supported to allow for excavation under the electrical duct bank for installation of the piping.

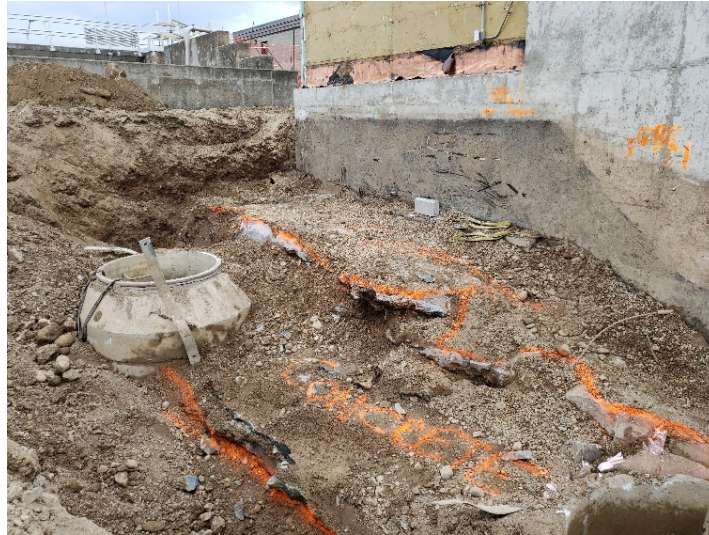
Photo No. 5

- Northside of existing Headworks Building,
- Exposed abandon concrete/grout from original construction,
- At one location, concrete approximately 2.5 meters deep
- Excess concrete/grout not properly disposed during original construction.
- Extra project costs to remove portions of the concrete above future slab elevation,
- Extra project costs in pile foundation installation, drilling thru concrete

During the month of July, the area to the north of the current headworks was excavated to allow for the installation of the pile foundation. During the excavation, the contractor encountered a significant concrete/grout mass left from the original construction in the 1990s. The concrete/grout mass likely resulted from the disposal of surplus concrete and grout that was dumped on the north side of the existing headworks building during the initial plant construction. There was no information in the engineering record drawing of such a large mass and this mass impacted the installation of 12 foundation piles for the headworks building expansion. There was a need to either remove or drill thru the concrete mass to install the pipe foundations. Again, good collaboration between JL Richards, H2Ontario and the Town resulted in removing some of the top concrete to elevation with a hydraulic jackhammer to ensure the correct top of concrete elevation and drilling thru the concrete mass at the pile locations so the piles could be installed. The contractor, through the consultant, prepared a change order request for the excavation of the mass, based on time and material. The total cost of this change order was \$17,142 and again the staff project manager was on site full time to ensure the extra charges were correct. See Photos No. 5 and 6 in the attachment.

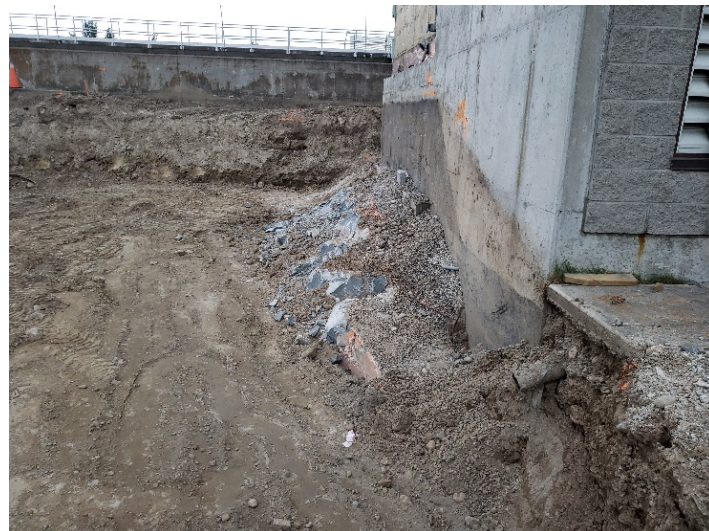
Photo No. 6

- Northside of existing Headworks Building,
- Concrete portion not removed since micro pile foundation could drill thru remaining concrete.

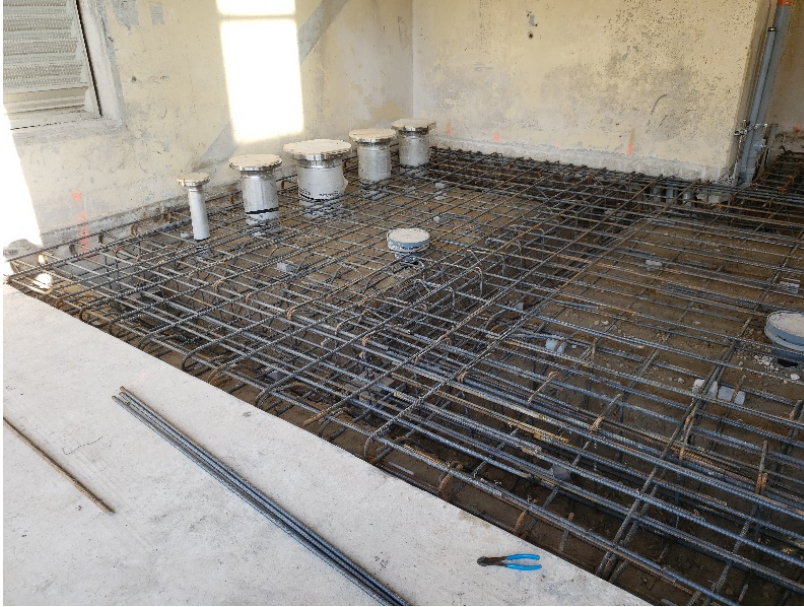
Photo No. 7

- Inside Existing Headworks Building
- Rebar installation prior to concrete being installed

During the month of August 2020, the current headworks building was gutted; removing all the equipment that had reached its end of useful life. The floor was excavated, and micro-piles installed to support the new equipment. The sump pump in the building required a new secure lid and this addition was not captured in the original scope of work. The contractor has sourced a lid and the additional cost of \$4,053 has been captured in a contract change order. The new floor has been poured in the existing headworks building and the walls have been washed and painted. See Photos No. 7, 8 & 9 in the attachment.

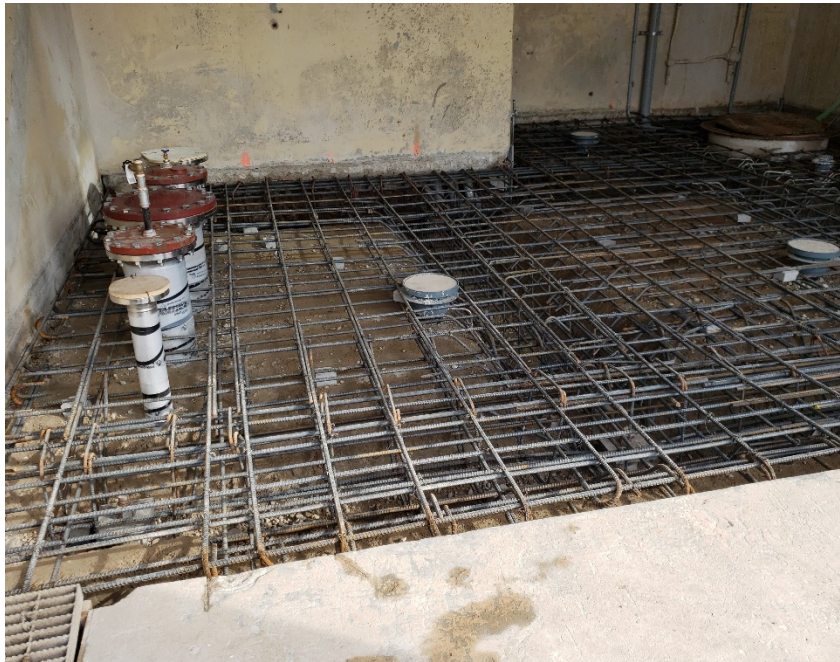
Photo No. 8

- Inside Existing Headworks Building
- Rebar installation prior to concrete

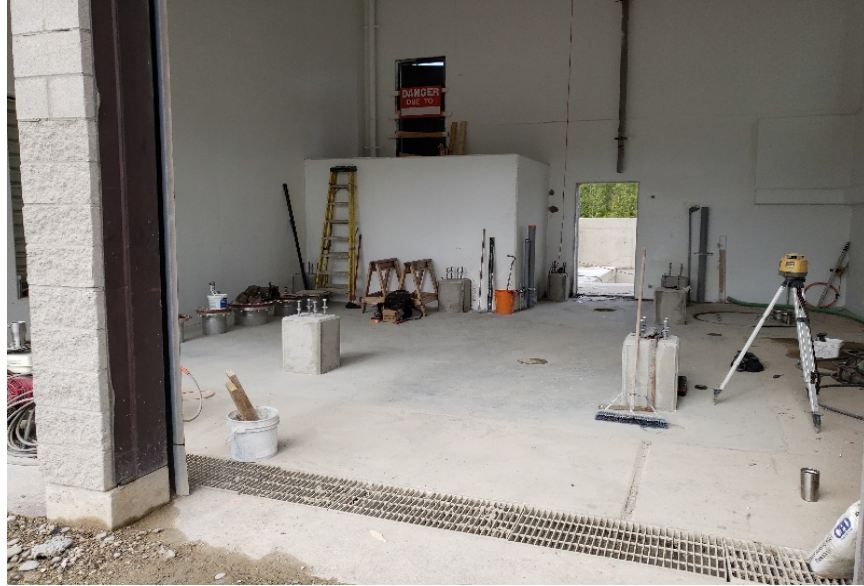
Photo No. 9

- Inside Headworks Building as of Oct 5th,
- Foundations ready for arrival of structural steel to support mezzanine level.

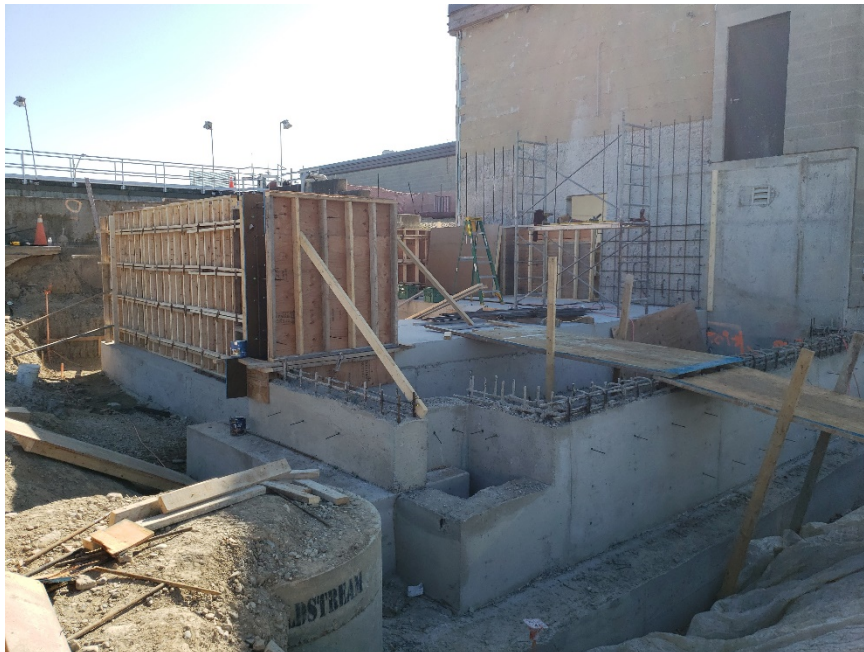
Photo No. 10

- Construction of the Additional Headworks Building
- Building will House vortex Grit Tank

During the months of August and September, rebar inspections were completed by the Town's Building Department for the building foundations, floors and wall section. There were 3rd party consultants involved in the approval of granular backfill and concrete testing. During October the block wall construction commenced and is anticipated to be completed by mid-November. During November the interior structural steel will be installed in the existing building section. See Photos No. 10 and 11 in the attachment.

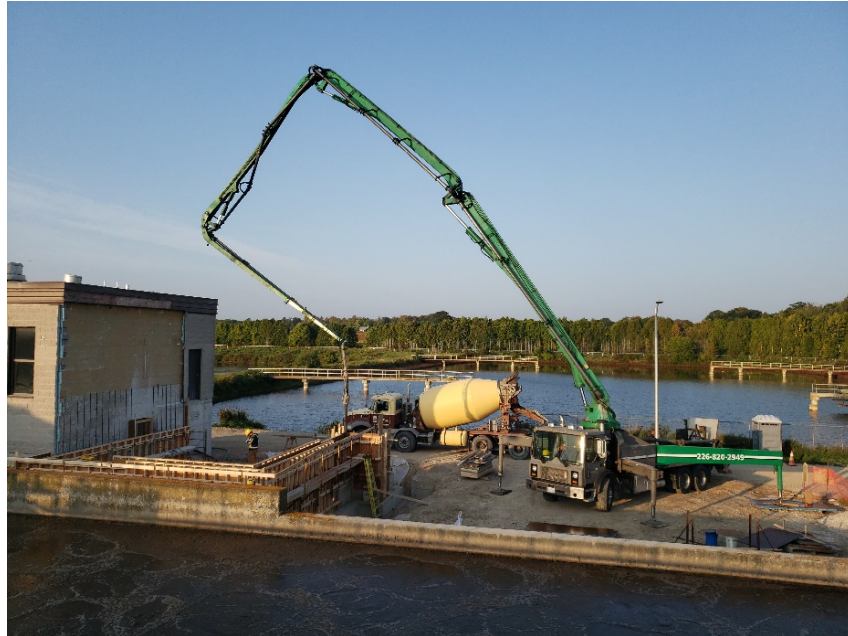
Photo No. 11

- Construction of the Additional Headworks Building
- Building will House vortex Grit Tank

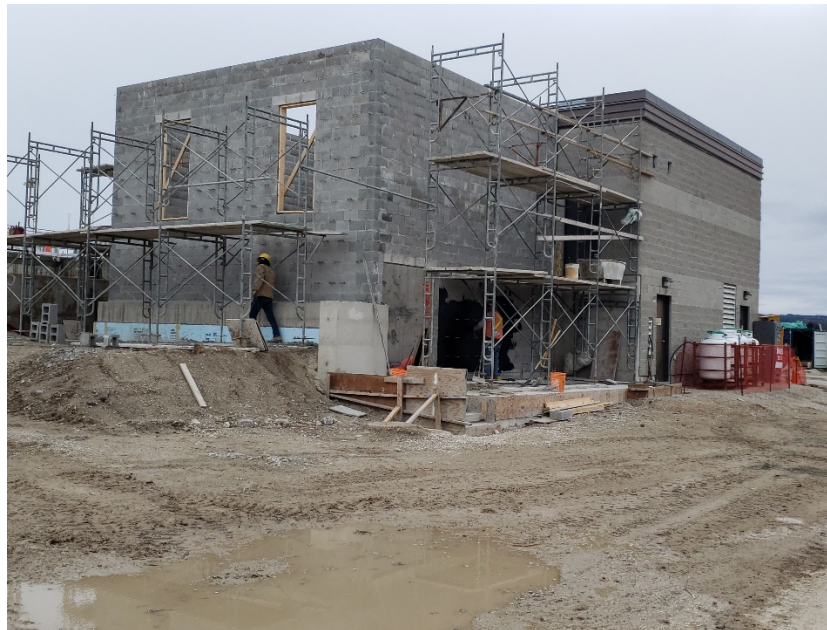
Photo No. 12

- Construction of the Additional Headworks Building
- Blockwall has been completed and starting vapour barrier and insulation

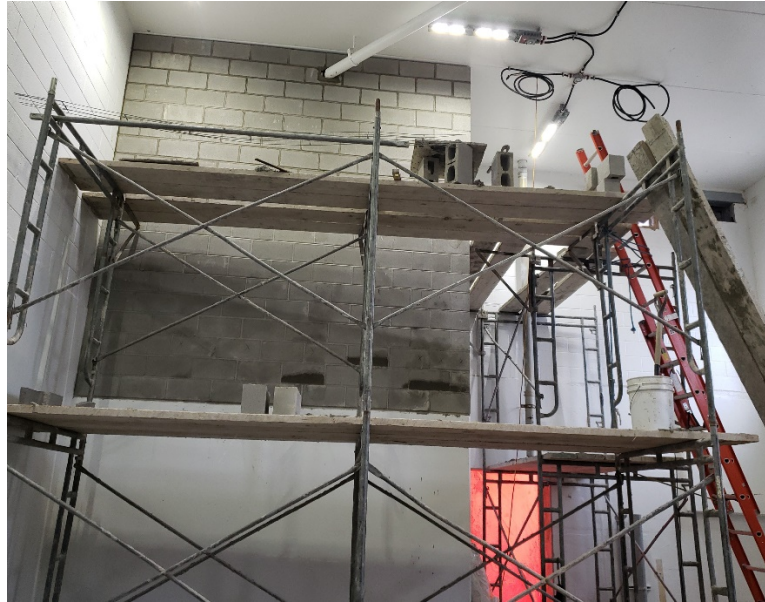
Photo No. 13

- Construction of the MCC Room Expansion inside the existing building
- Blockwall has been completed and painting still to be completed

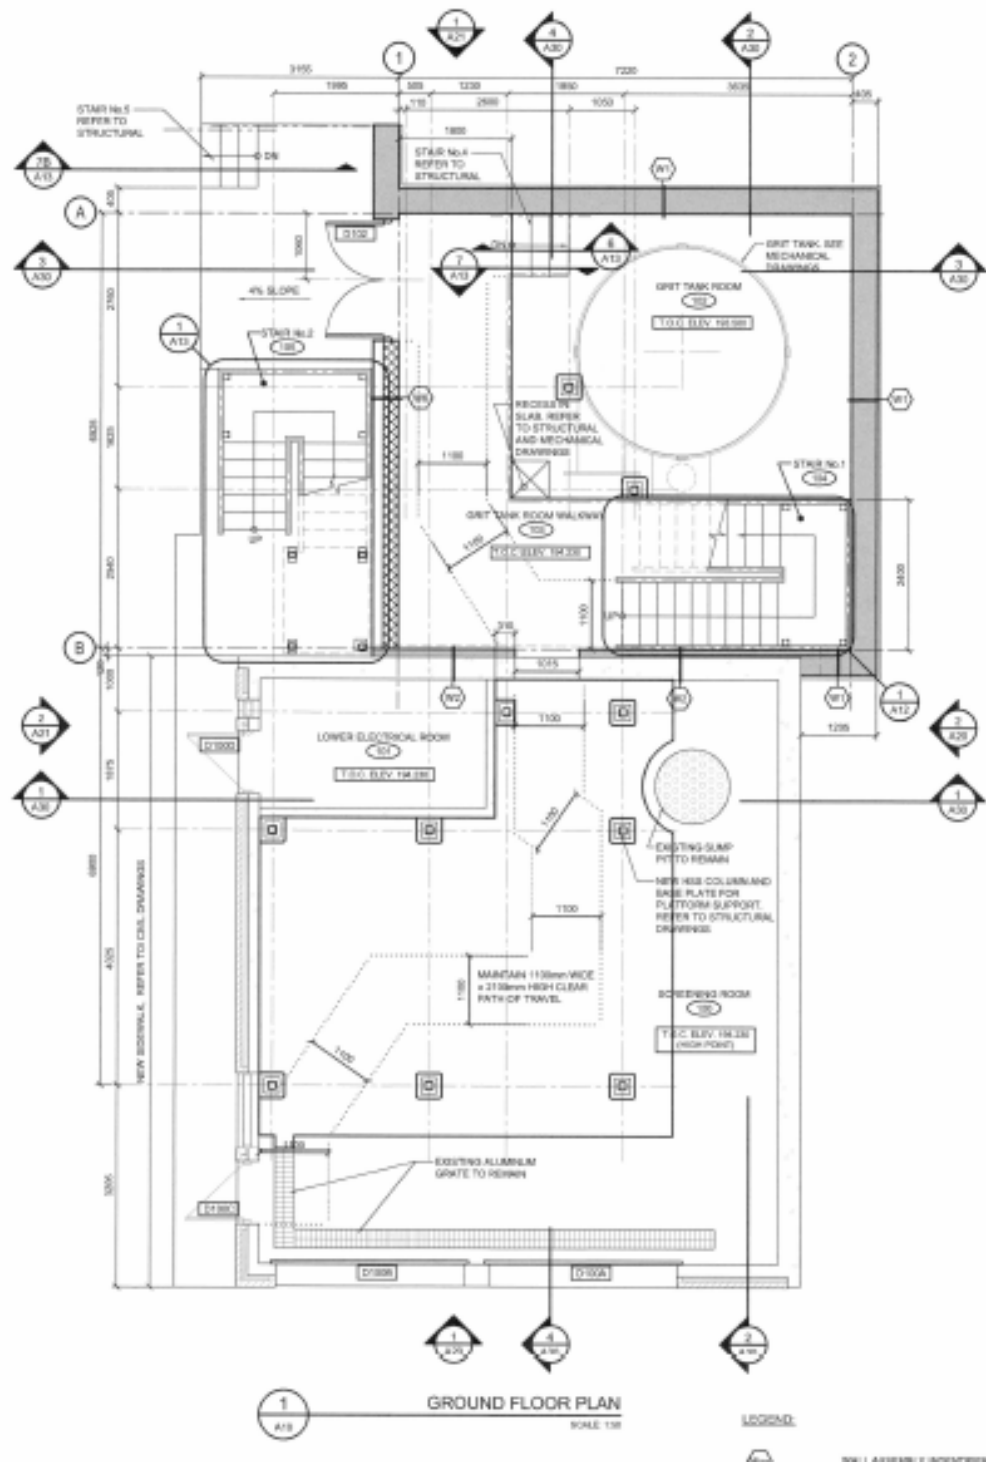
Image 3: Ground Floor
