Report To: COW - Operations, Planning and Building Services
Meeting Date: March 18, 2025
Report Number: OPS.25.017
Title: Happy Valley Reservoir Budget Increase
Prepared by: Allison Kershaw, Manager of Water & Wastewater Services

**Happy Valley Reservoir (North and South)
Remotely Operated Vehicle Inspection and Report
July 31, 2019**

Remotely Operated Vehicle Inspection & Report (ROV) – Happy Valley Reservoirs (North and South)

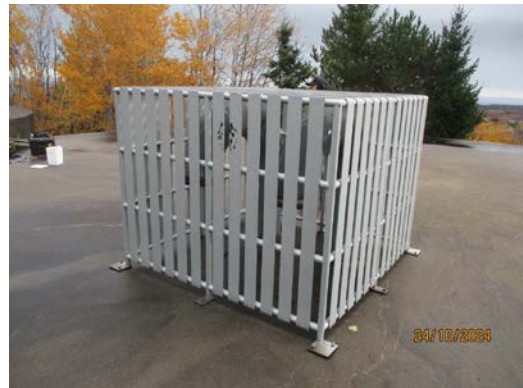
Protective cage around two gooseneck vents

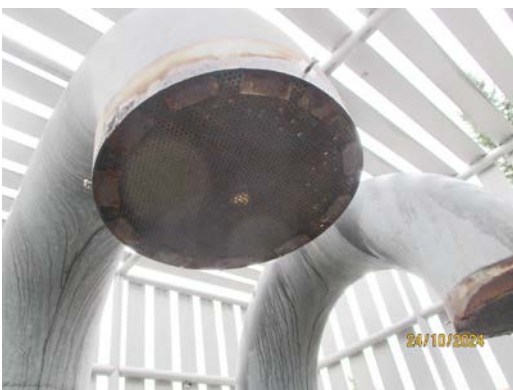
Underside of 1st gooseneck vent screen – ok

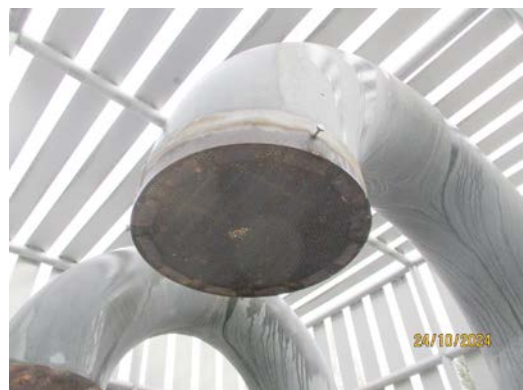
Underside of 2nd gooseneck vent screen – ok

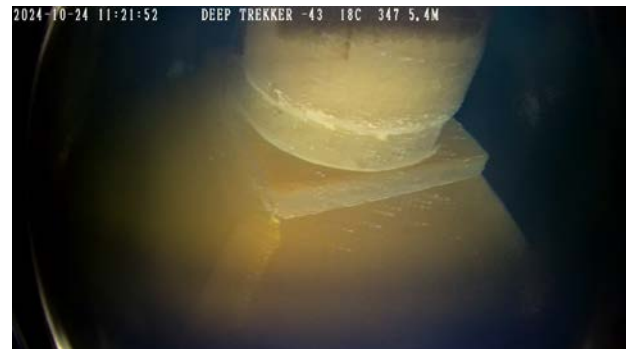
View down at roof support pillar to floor interface

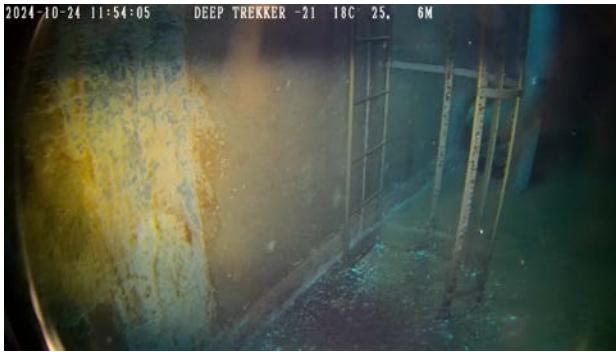
Ladder bottom, see pipe and support behind it

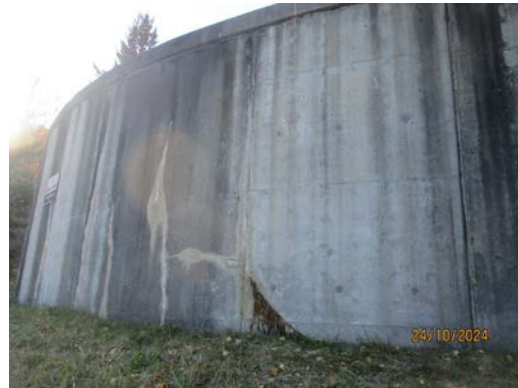
Wide view of area where wet deposits are seen

- 4.5 Remove external calcium and other deposits seen at random areas of the reservoir and at joints and monitor periodically to see if these areas have active leakage or increasing size.

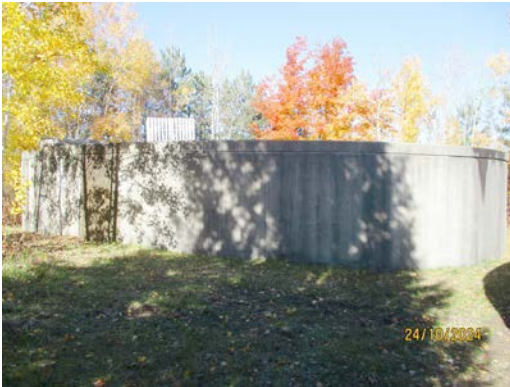
Overall view of the North Reservoir

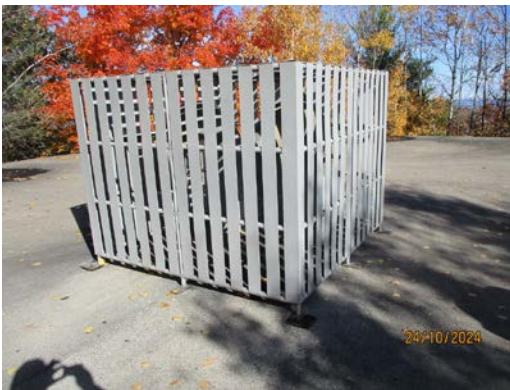
Protective cage around roof vent piping

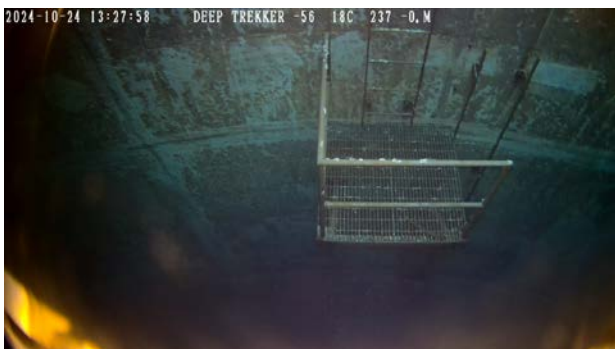
View down at ladder platform

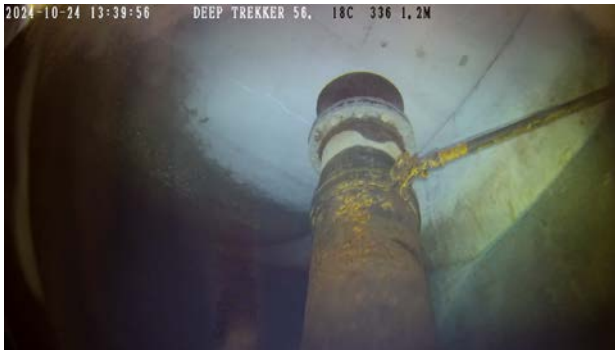
Upper portion of overflow pipe and bracket

- 4.2 Plan to dewater and enter each of the two reservoirs and perform cleaning as well as more detailed inspections of the metal parts, thickness of piping, bolting corrosion including removal of scale and failed coating to better assess condition of these metal components.
