Report To: COW - Operations, Planning and Building Services
Meeting Date: March 18, 2025
Report Number: OPS.25.017
Title: Happy Valley Reservoir Budget Increase
Prepared by: Allison Kershaw, Manager of Water & Wastewater Services

**Happy Valley Reservoir (North and South)
Remotely Operated Vehicle Inspection and Report
July 31, 2019**

Remotely Operated Vehicle Inspection & Report (ROV) – Happy Valley Reservoirs (North and South)

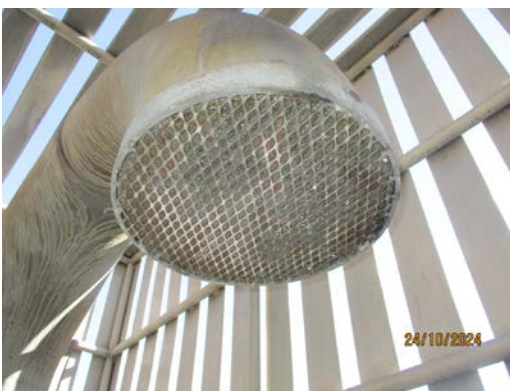
Vent one of two, screening is ok

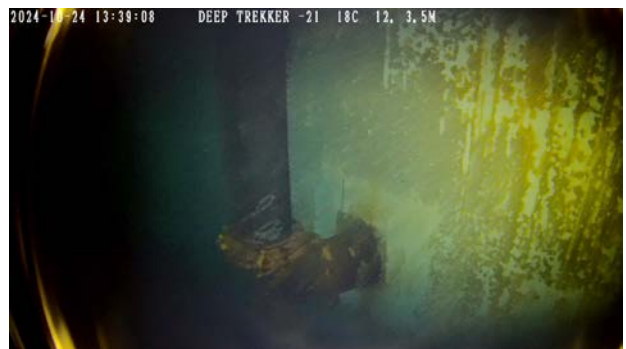
Overflow pipe to wall interface

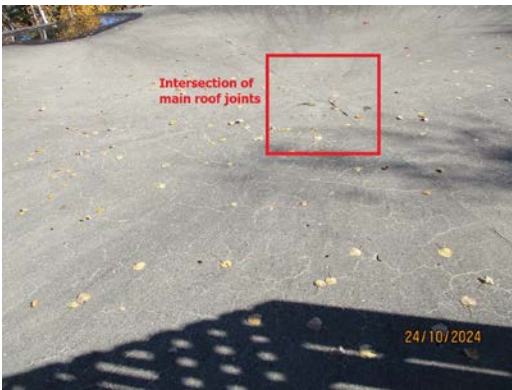
Typical white deposits

- 4.5 Remove external calcium and other deposits seen at random areas of the reservoir and at joints and monitor periodically to see if these areas have active leakage or increasing size.

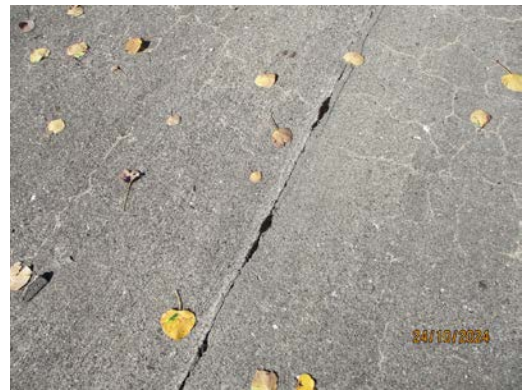
Area of the intersection of topside roof joints
